(9) BUREAU OF SHIPS GROUP
TECHNICAL INSPECTION REPORT

(6) OPERATION CROSSROADS.
U.S.S. GASCONADE (APA85).

(8) TEST ABLE [U].

USS GASCONADE (APA85)

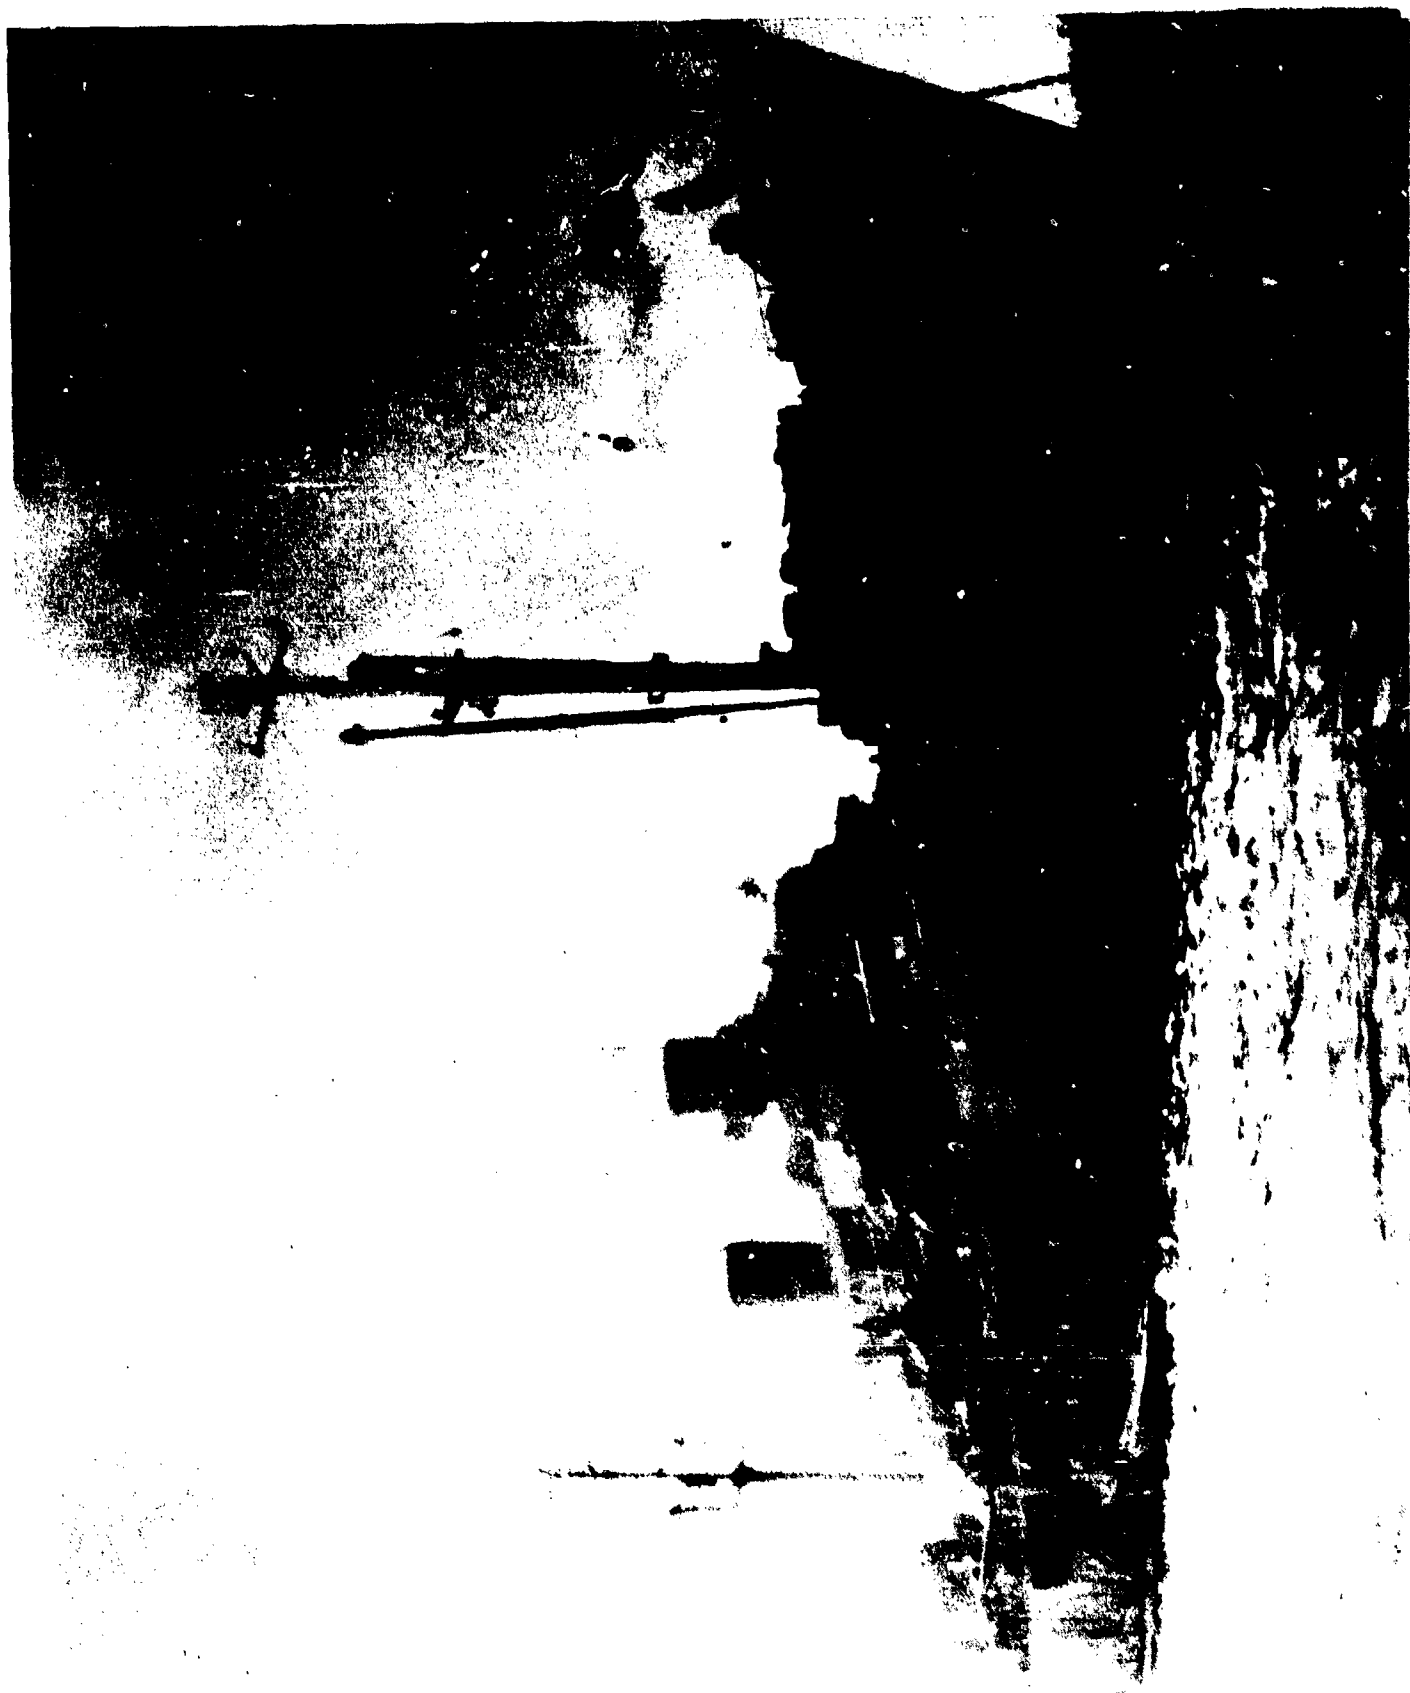
AA-CR-227-50-68. View from off starboard bow after Test A.

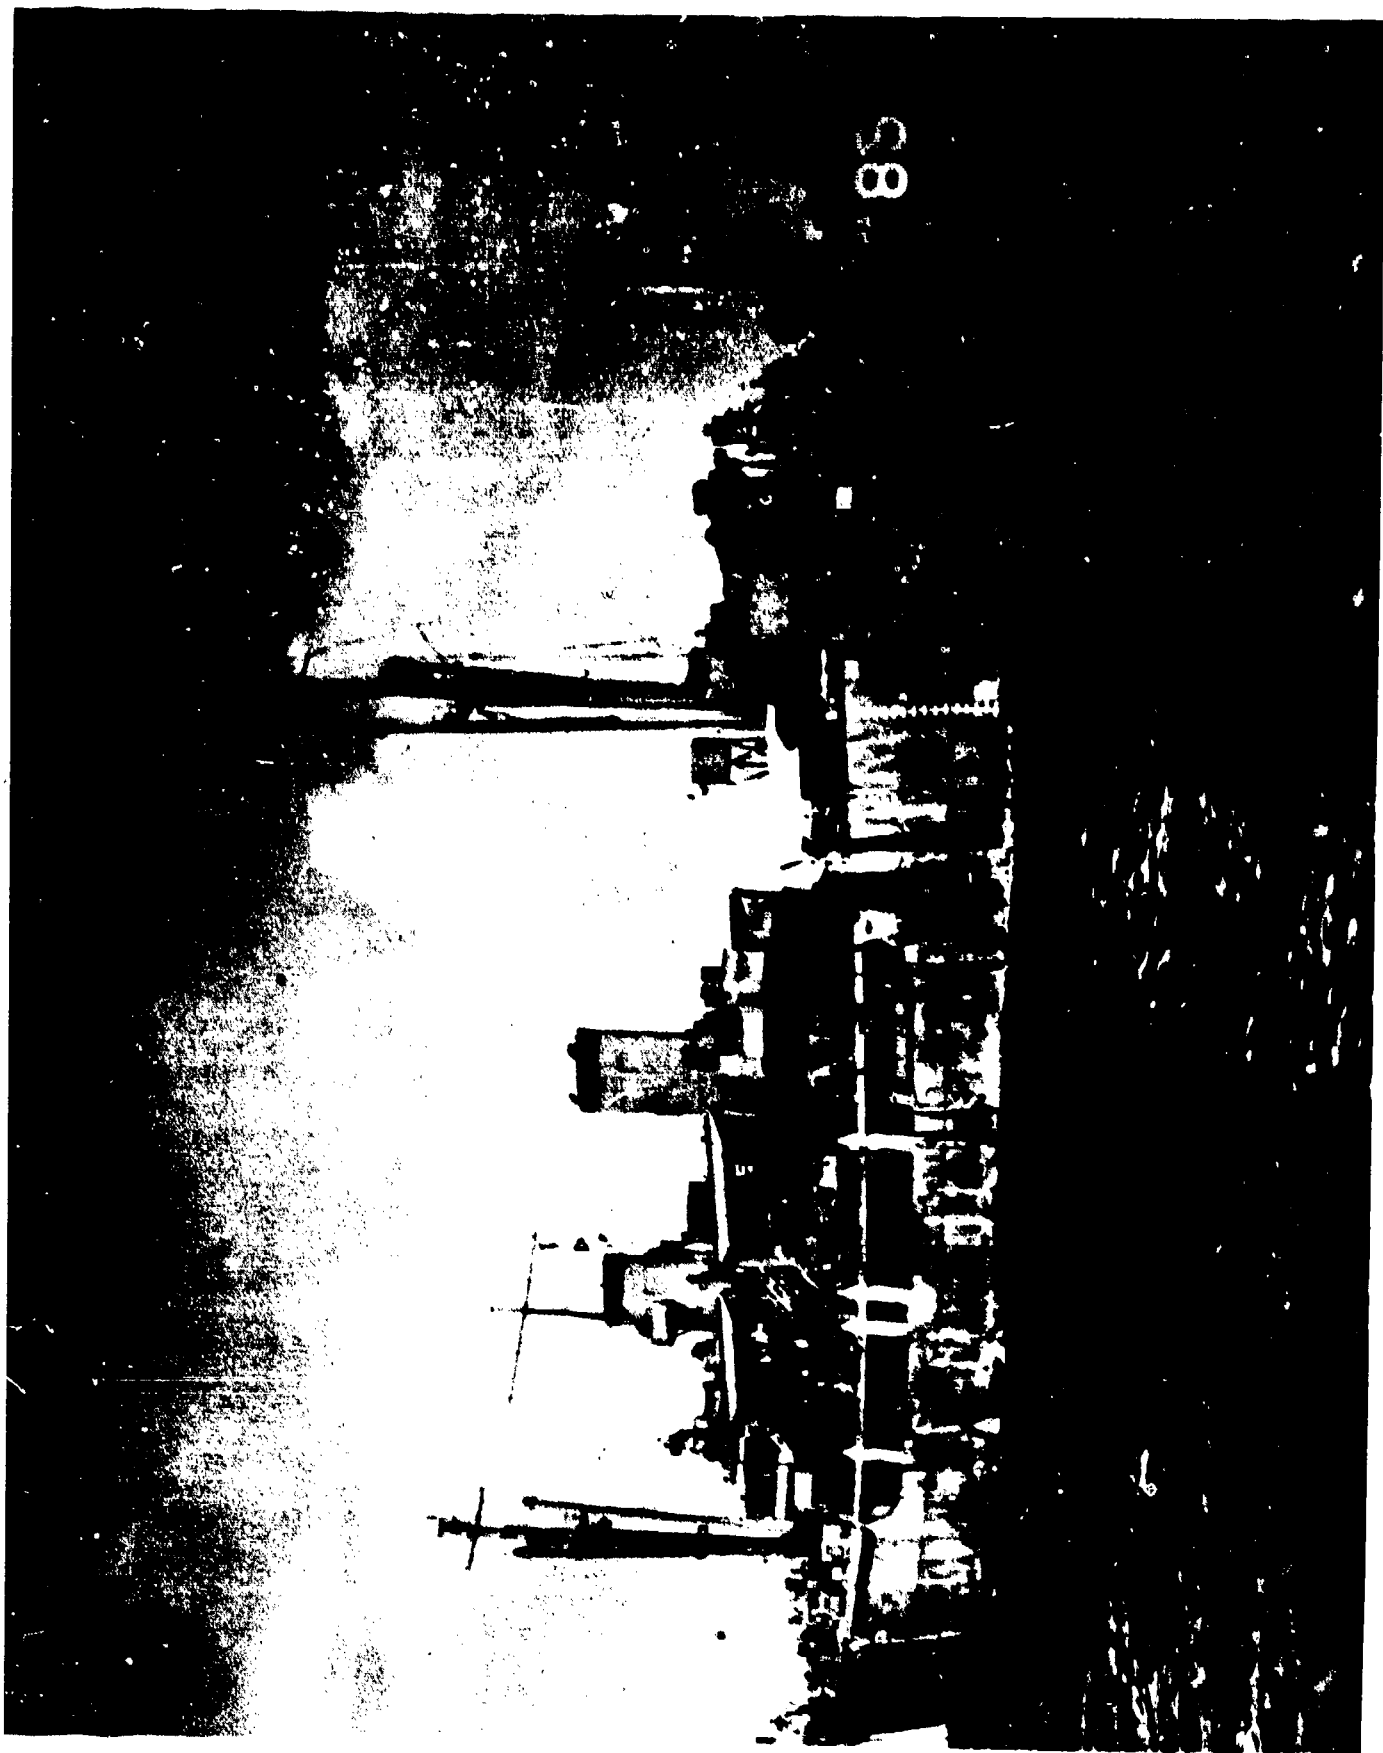
AA-CR-227-50-64. View from off port quarter after Test A.

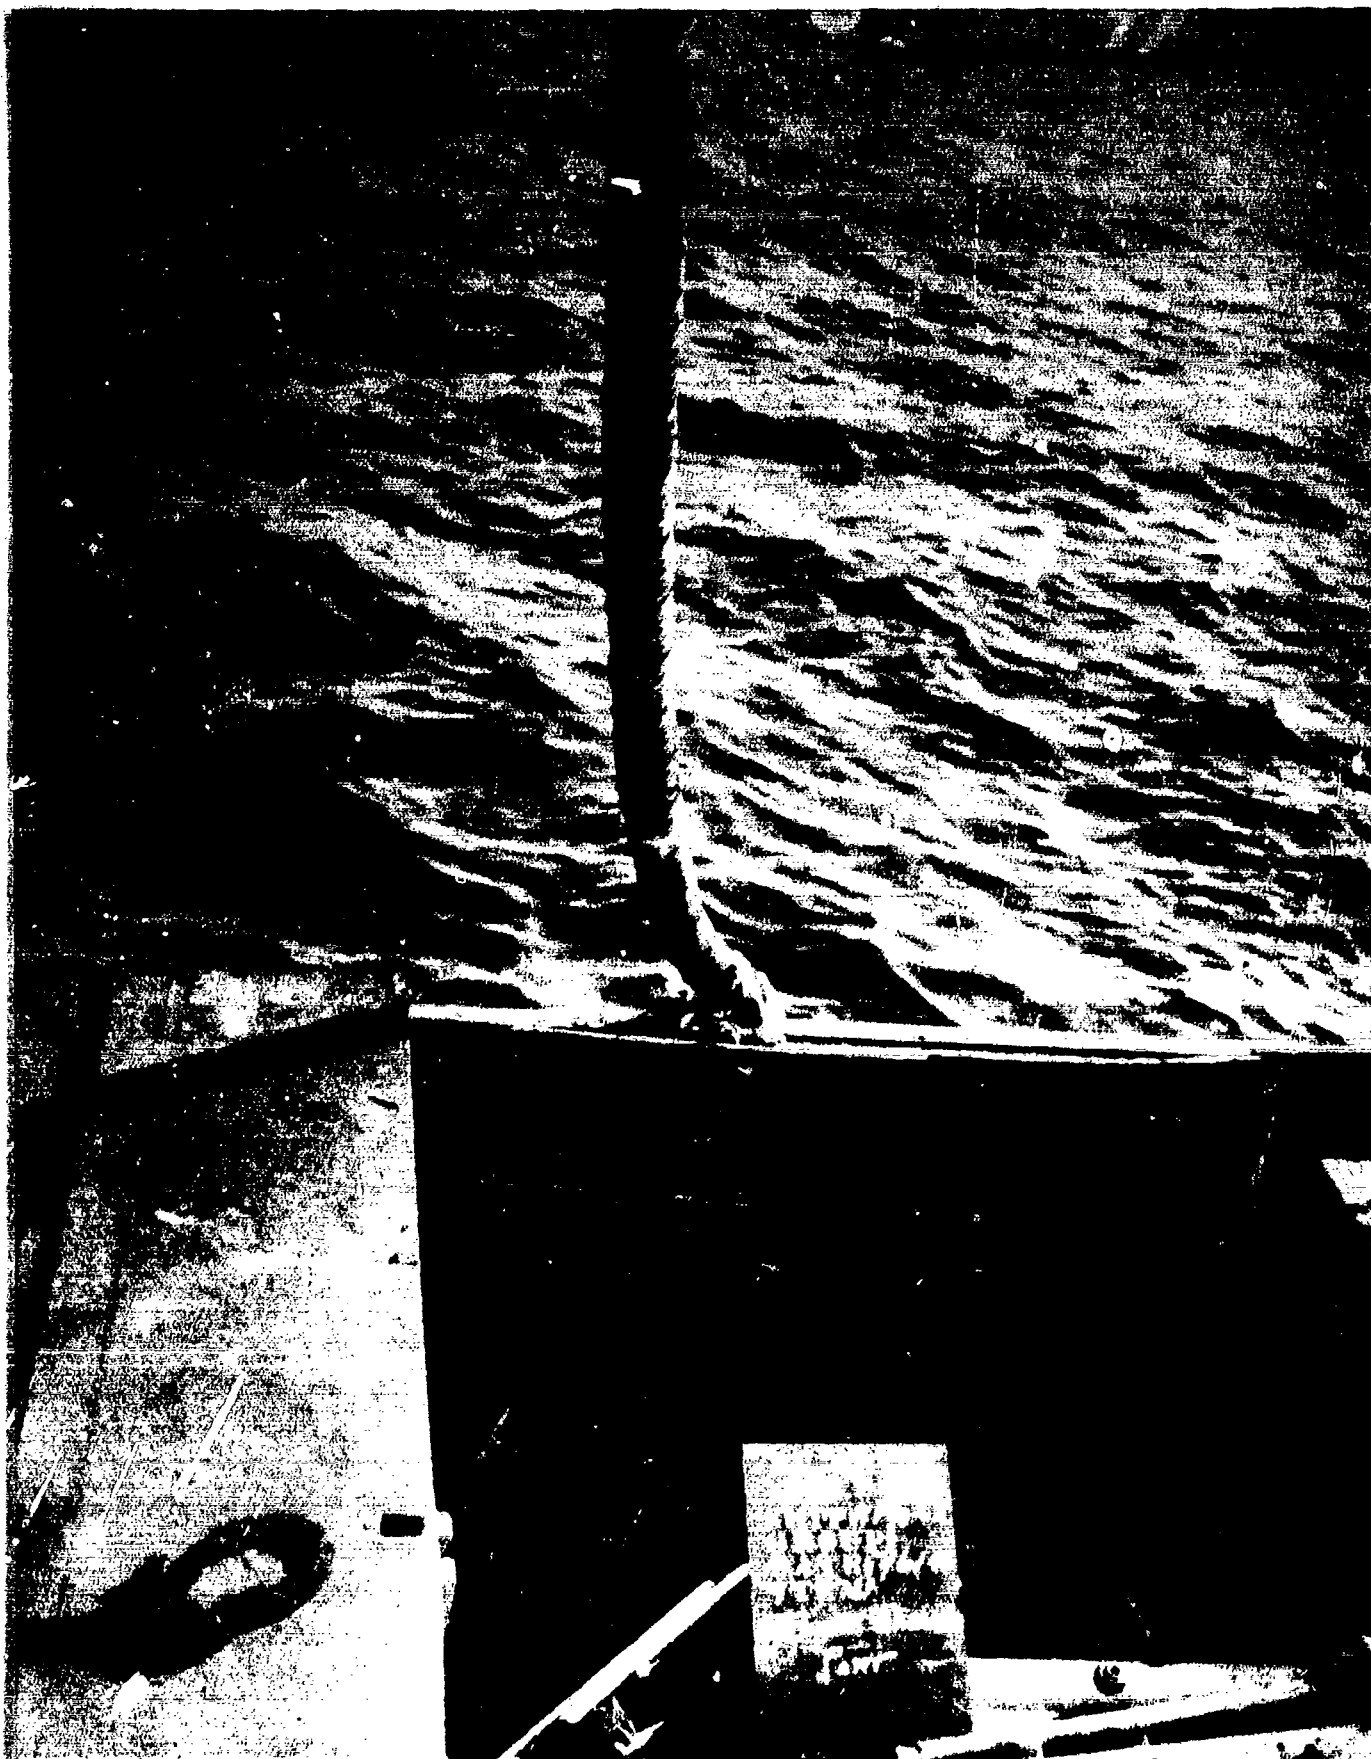
AA-CR-65-1737-8. Detail of scorched gripe on No. 2 Welin davit.

1. Graphite grease on running rigging dried to caked carbon, reducing flexibility.
2. Boat gripe davit 4, burned down to bare wire; gripe on davit 2, scorched.
